When Father Christmas wore a boiler suit

ERIKS' engineering doing what Santa's elves couldn't

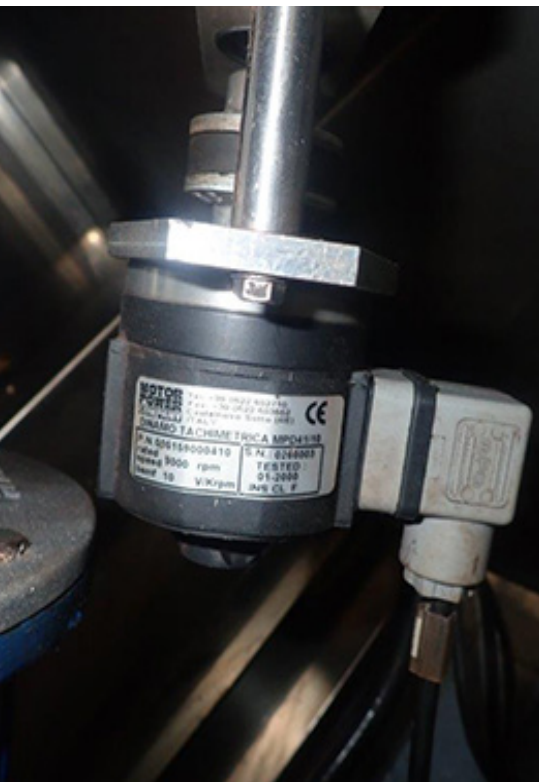
Tachometer fitted to input shaft

The first was to modify the input shaft to accommodate the tachometer connection. The second was to manufacture an entirely new double worm output shaft. And the third was to reposition the tachometer onto the non-drive end of the motor.

The customer carefully considered all three alternatives, before deciding that the first solution – a gearbox modified to enable the input shaft to connect to the tachometer – was the preferred choice. There was, however, one important caveat. To minimise downtime and avoid excessive lost production, ERIKS was tasked with completing the modification over the customer's Christmas shutdown period, so the replacement gearbox would be ready for installation immediately before production restarted after the holidays.

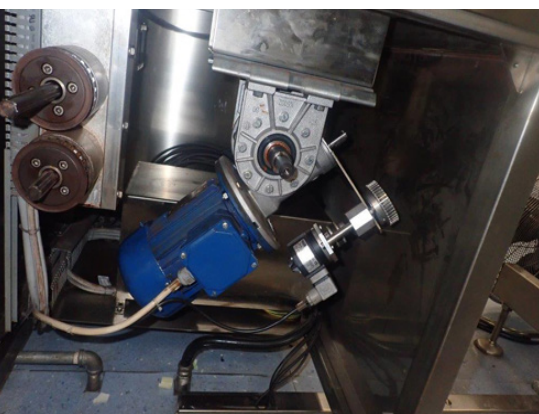
Critical non-standard gearbox in-situ

His expert inspection confirmed that extensive wear to the gearbox internals would inevitably soon lead to catastrophic failure. With no chance of the replacement OEM gearbox being delivered before the asset failed, some suppliers would have struggled to come up with even one answer to the problem. ERIKS presented the customer with three possible options to save the day.

The first time-saving step was to decide to carry out an adaptation of a standard gearbox rather than starting from scratch to build a special unit. The adaptation required was to accommodate a double input: one for the motor and one for the tachometer. However this wasn't as simple as merely modifying the worm shaft. Complicated calculations were required in advance of specifying the modifications, to ensure the proposed changes didn't affect transmission of the correct amount of torque.

With the calculations worked out to the satisfaction of the engineers, and the manufacturing drawings completed, the adaptation of the standard gearbox could begin. Firstly, the gearbox had to be dismantled ready for the changes to be made. Then the worm shafts had to be modified to suit the new design. And of course the gearbox casing also required adaptation and re-engineering, to accommodate the double output worm shaft.
