New belt shows its grit against gravel

Longer life, greater efficiency - and less costly too

Application:
Vibratory screens

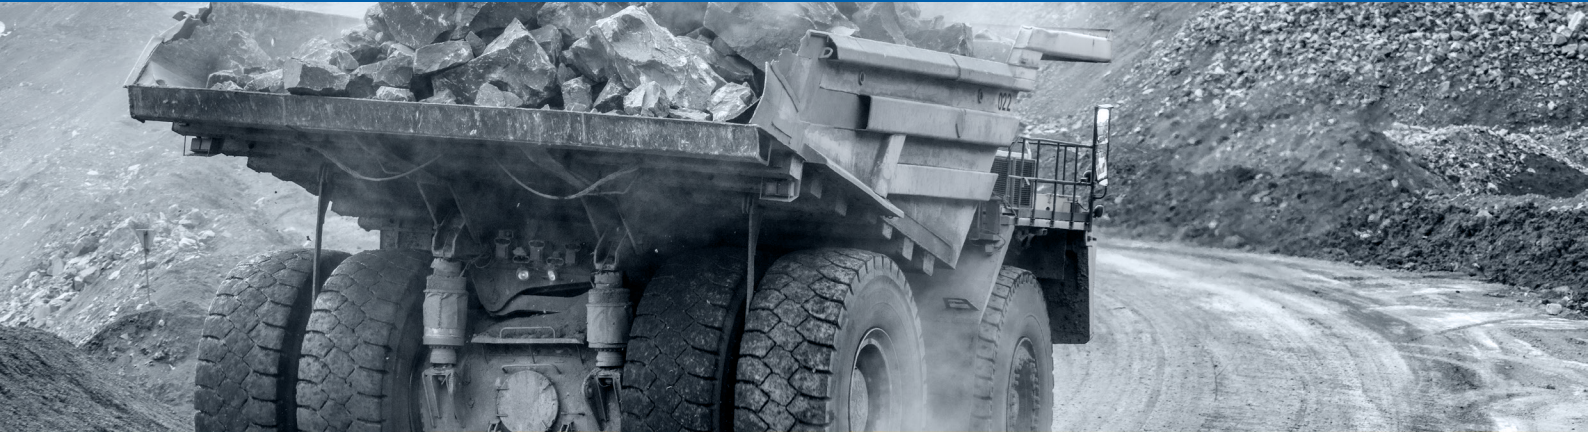
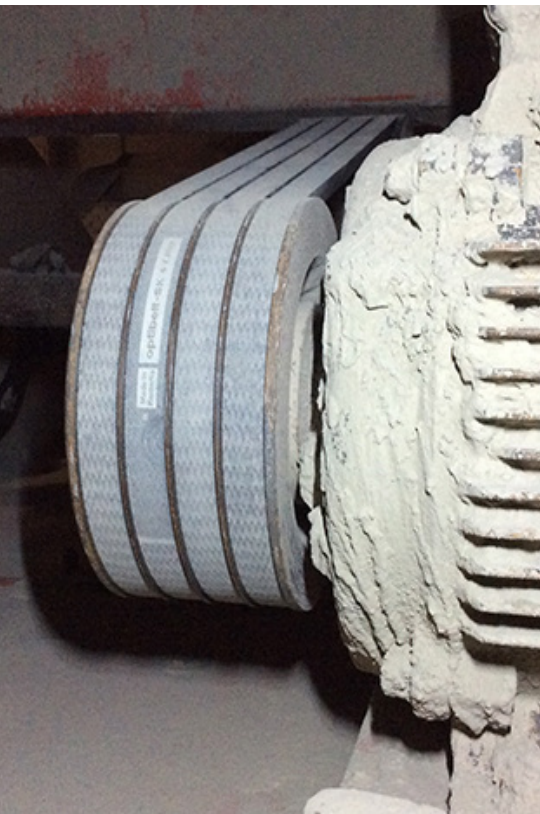
This on-site inspection first considered the three most likely causes of belt failure: the belt is incorrectly tensioned; the pulleys are misaligned; the pulleys are worn. Assessment – including the use of a laser alignment tool – revealed that the alignment and tension were satisfactory, but that new belts were being fitted to worn pulleys, and some of these belts were of insufficient quality.

These two factors combined with the ingress of dust from the environment, leading to excessive heat. This was causing the belts to undergo a secondary cure during use – making them unstable and more likely to snap.

Close-up of original setup

Although the customer had installed dust guards to try to prevent dust ingress, this was insufficient to keep the belts dust-free.

ERIKS' know-how led the engineer to propose the Fenner® Quattro PLUS CRE heavy-duty V-belt, manufactured from synthetic rubber EPDM. This belt not only has an extended operating temperature range of -40°C to +130°, but also has an enhanced tooth profile. This is designed to improve belt flexibility and reduce bending resistance, but has the added benefit of helping to dissipate heat build-up.

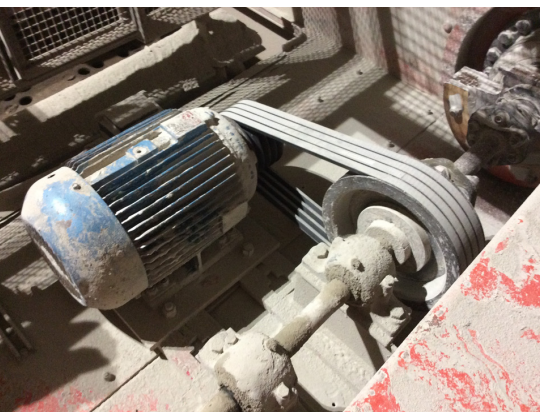
Fenner belt drive now in-situ

New Fenner® Quattro PLUS CRE belts were fitted to all the customer's vibratory screens, and ERIKS monitored their lifespan.

The monitoring revealed that the Fenner belts were lasting twelve months at least. All of the alternative belts previously fitted had lasted no more than six months on average before failing.
